**\*\* MANDATORY \*\***  
**SERVICE BULLETIN**

NO.: 0823 Rev B

SUBJECT: GDU 104X CRS/BARO Knob Interference

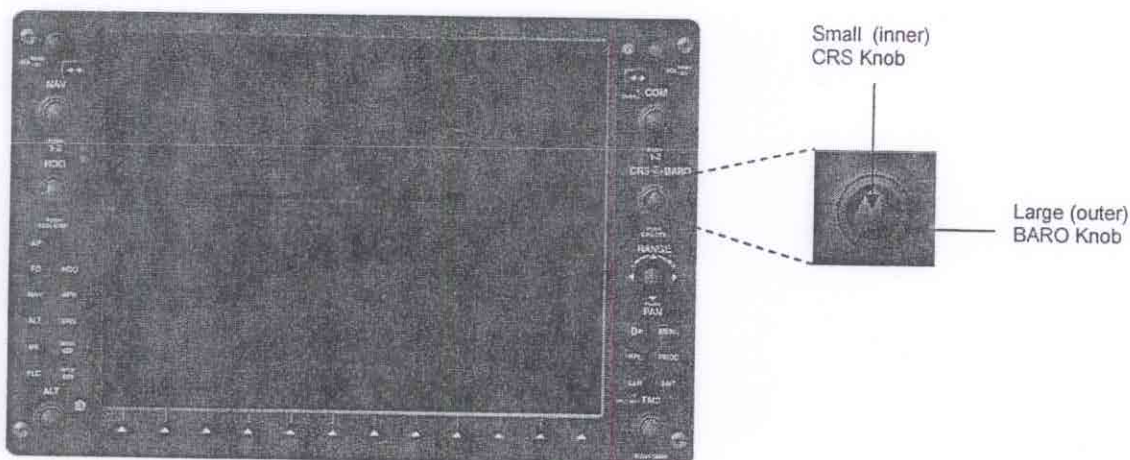
**Figure 1**

Garmin has identified an issue, whereby the large (outer) BARO knob and the small (inner) CRS knob may interfere with each other.

If CRS/BARO Knob interference is confirmed, perform the steps below to replace the CRS/BARO Knob. New knobs can be obtained through a Garmin Service Center or Aircraft OEM under Garmin part number K00-00446-00.

1. Grasp the small (inner) CRS knob and firmly pull the knob off the shaft.
2. Discard knob.
3. Grasp the large (outer) BARO knob and firmly pull the knob off the shaft.
4. Discard knob.

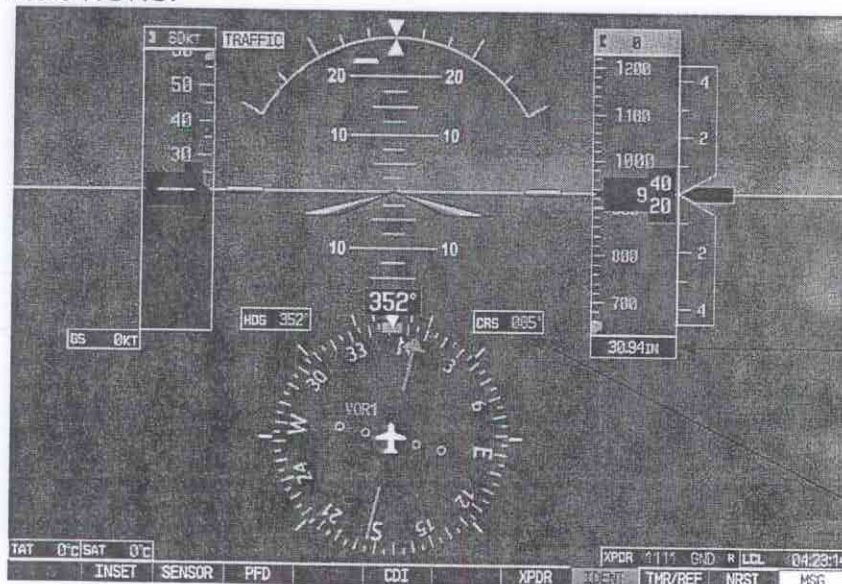
Figure 3

4. Rotate the small (inner) CRS knob (refer to Figure 1) a minimum of three complete revolutions in each direction while monitoring the Barometric Altimeter Setting (refer to Figure 3) on the PFD. If a change in the Barometric Altimeter Setting is produced while turning the CRS knob proceed to the Modification Instructions.
5. Repeat Steps 3 and 4 for each affected GDU.
